Topic... The alleged fragmentation of bullet CE 399

From.... Dick Bernabei

This memorandum deals with the question whether bullet CE 399 lost any of its substance in the form of fragments from any place on its surface. The evidence bearing on the question proves that CE 399 lost no fragments.*

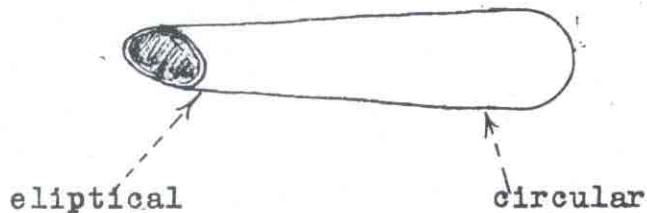
The generally elliptical shape of CE 399 at and near its base indicates that in the course of its trajectory it came into contact with a substance of sufficient density to squash the rear portion of the bullet longitudinally. The circumference of CE 399 is circular near the nose; the elliptical deformity is apparent about half way down the bullet's length and becomes progressively more pronounced as it approaches the base. The following diagram illustrates the elliptical deformity of CE 399:

The cause of this deformity cannot definitely be ascertained, but the most likely explanation of the deformity is that, inhibited by the substance which it penetrated, the velocity and spin of the bullet were reduced sufficiently to cause the bullet to be unstable and to tilt. Proceeding along its trajectory in this tilted posture, one side of the bullet pressed heavily against the resistant substance and thereby became squashed.

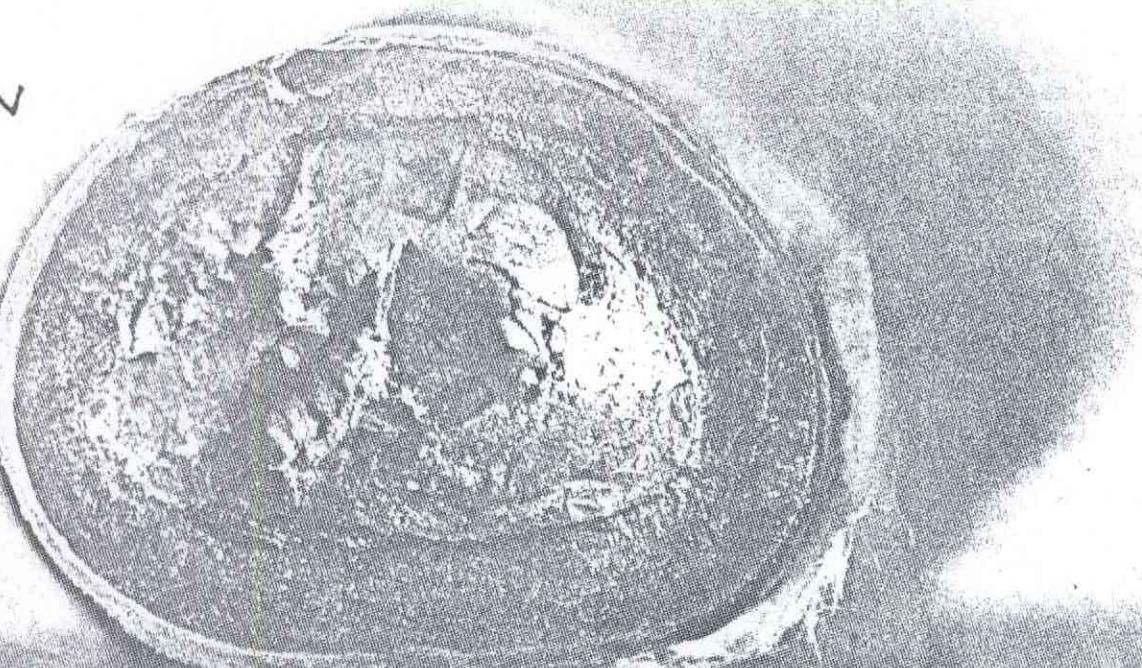
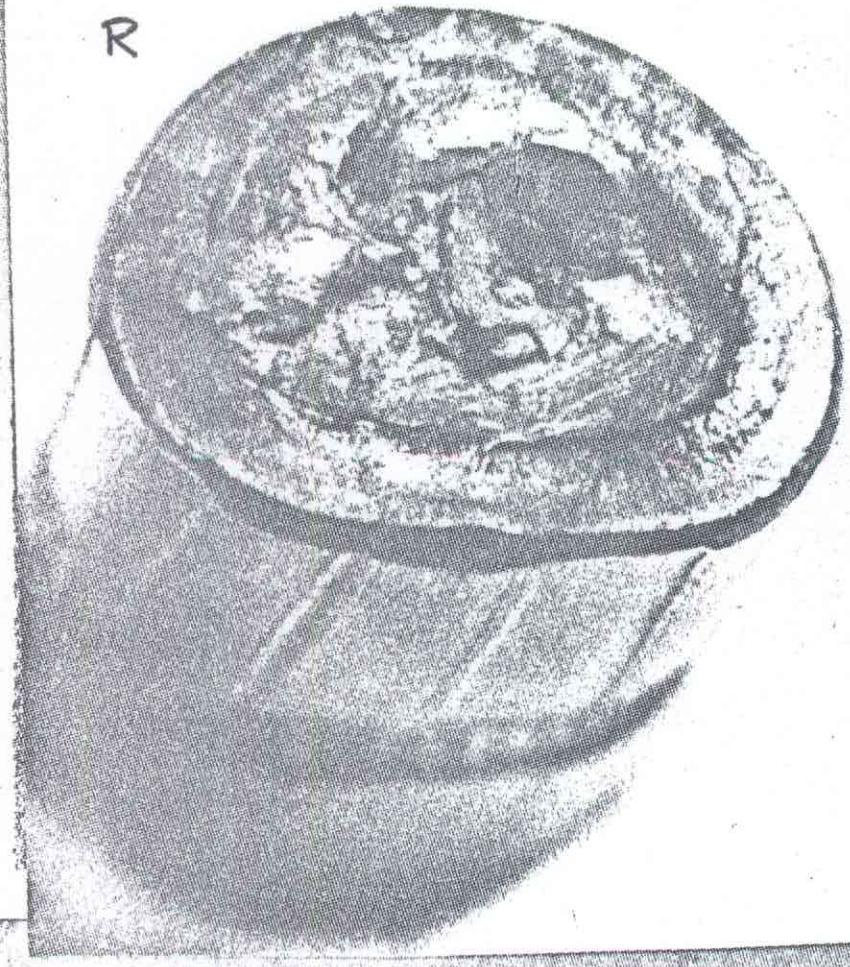
Exhibit 2 (attached) is a Xerox copy depicting two separate photographs that show the base of CE 399. This exhibit and others like it are intended only to illustrate the location of various topographical features that occur on the surface of the base. Details discussed in this memorandum refer to the photographs themselves which are in the possession of those who receive this memorandum.

The photograph designated "photo-W" was made at the National Archives for Harold Weisberg in 1967; the photograph designated "photo-R" was made at the National Archives for Howard Roffman in 1968. Photo-R was taken at a considerably greater distance from the bullet than photo-W, and therefore fails to resolve minute details of the base as clearly as photo-W.

Photo-W, the clearer of the two photographs in Exhibit 2, discloses the presence of a grainy substance (henceforth referred to as "powder") all over the lead base of CE 399, except on "lumps A and B" and in places where lead was disturbed in ways unconnected with the actual shooting of the bullet. (These exceptions are discussed below.) In the "valley" the flecks of "powder" look like tiny grains of sand on the "valley" floor. On "lump C", around the "rim", and in the "hollow" the grainy substance appears as tiny dots of reflected light.

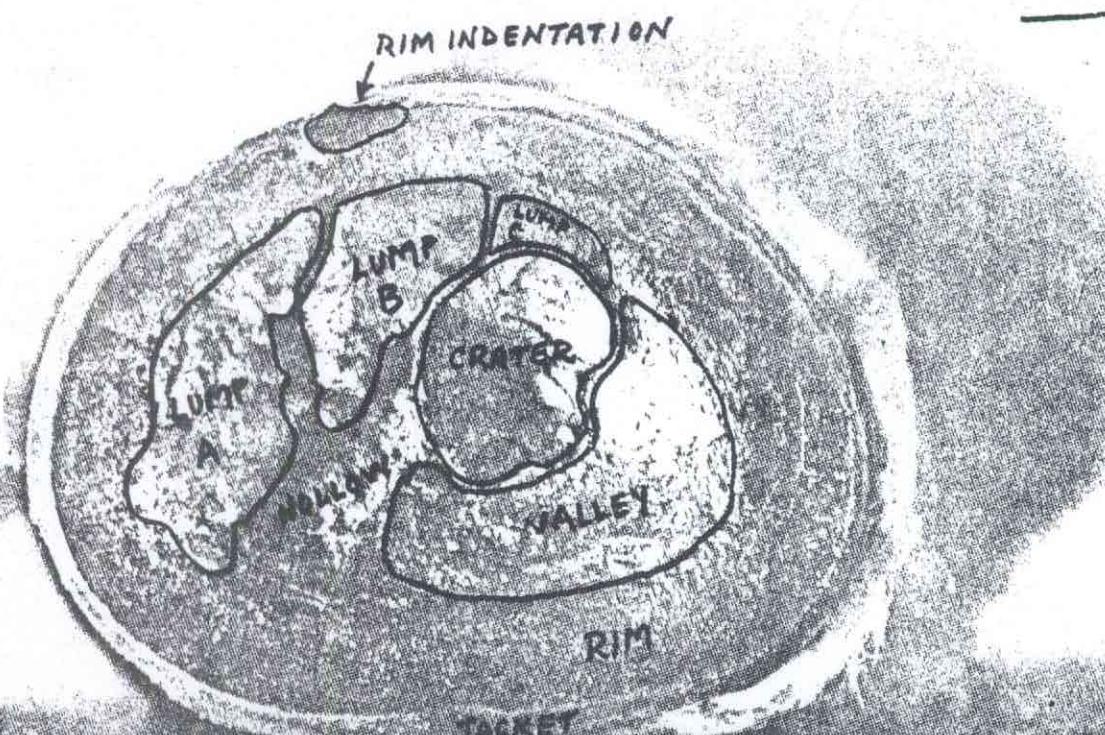
EXHIBIT 3

The following arbitrarily selected terms apply respectively to various topographical features that are evident in the two photographs which show the lead core at the base of CE 399. The locations of these features are designated in Exhibit 3:

- jacket (copper)
- rim
- rim indentation
- valley
- crater
- lumps A, B, and C
- hollow (area surrounded by other structures)

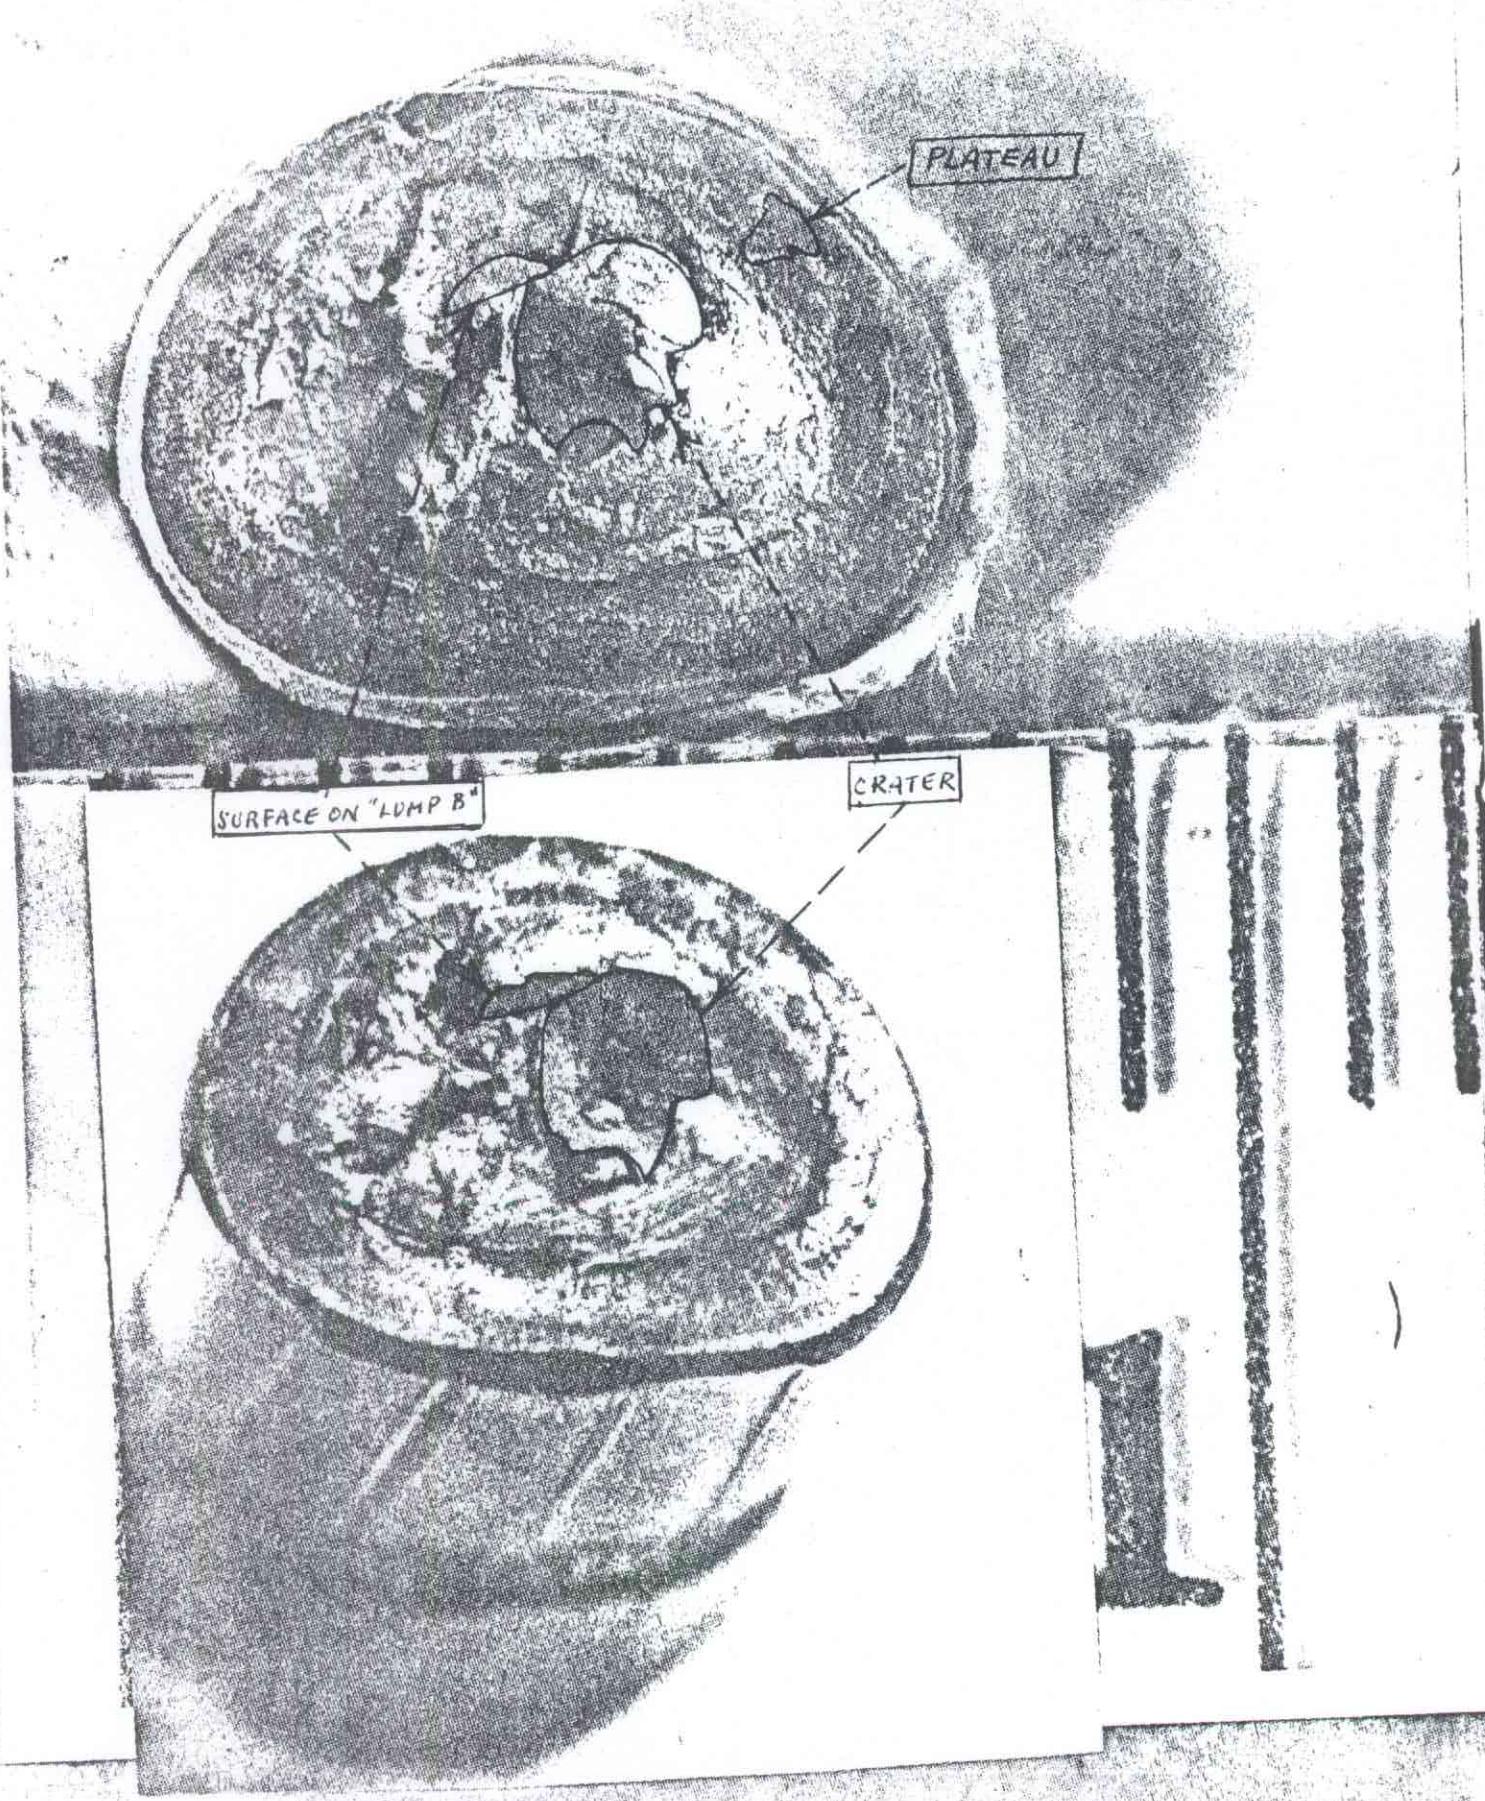
EXHIBIT 4

The only flat, unstriated surface on the base of CE 399 occurs on the "rim" in an area less than one millimeter in length. The location of this tiny "plateau" is indicated in Exhibit 4 (attached). Physical characteristics of the "plateau" indicate that its flatness resulted from mild pressure being applied at that point by some hard, relatively smooth surface.

Characteristics of the conical "crater" and of a small surface adjacent to it on "lump B" indicate that it is from these places that FBI agent Frazier removed substance from the base for spectrographic analysis. Evidently Frazier used the tip of a sharply pointed knife with which to cut away a small portion of lead from the base. Conical craters similar to the one that occurs on the base of CE 399 can easily be reproduced by such means. Moreover, a pointed knife of a certain degree of sharpness regularly reproduces not only the conical "crater", but also minute lumps of lead at the bottom of such craters, lumps similar to those that occur at the bottom of the "crater" on the base of CE 399.

The reason for believing that a part of "lump B" was removed by a knife edge is that the surface in question is flat and striated.

The precise areas affected by the edge of a knife are indicated in Exhibit 4.
